ESTHETIC REHABILITATION OF PATIENT USING PORCELAIN VENEERS: A SERIES OF 3 CASE REPORTS

ABSTRACT

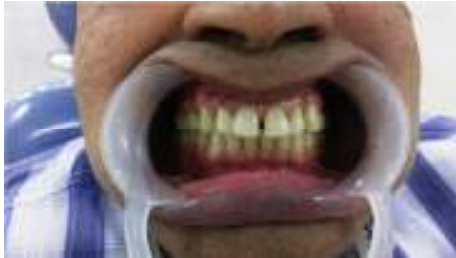
Figure 1(a): Preoperative view

Scaling was done before the treatment (Figure 1(a) and 1(b)). Shade selection (VITA classical) was done before the tooth preparation. After thorough examination impressions for the diagnostic model were made with alginate (Heraplast, Heraeus Kulzer, USA). The impression was poured in dental stone. On this model a diagnostic waxup was done to access the final outcome of the restoration (Figure 2). Incisal overlap preparation was chosen. Depth orientation groove of 0.3mm and 0.5 mm on the gingival and incisal half respectively. The structure in between the grooves was removed with round tapered diamond and a chamfer supragingival finish line was given. Mesially the finish line extended beyond the contact area and distally it was terminated facial to the contact area (Figure 3). The lingual finish line was placed with a round end tapered diamond, approximately one fourth the way down the lingual surface connecting the two proximal finish lines. The finish line should be minimum 1mm

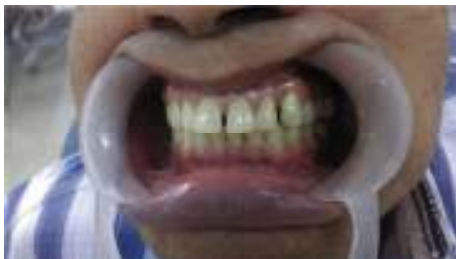
Figure 1 (b): Preoperative view rt. Side

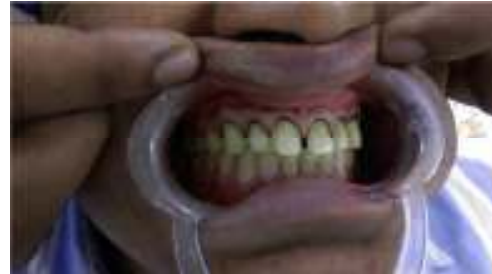
Figure 4: Gingival Retraction done

away from centric contacts. After the preparation was done retraction was done with retraction cord soaked in viscostat.(Figure 4) impression was made with two stage putty wash reline technique.(Figure 5).

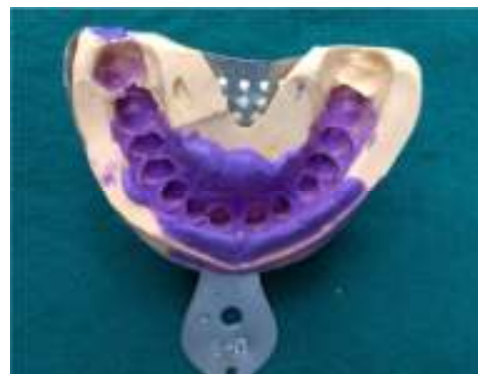
Figure 5: Impression of prepared tooth

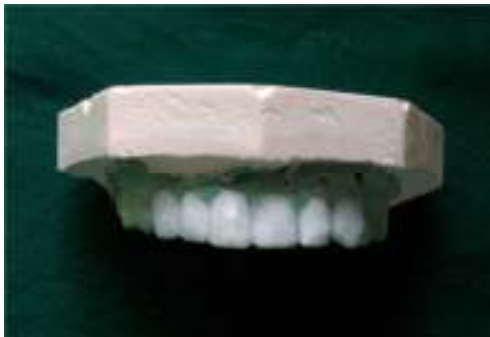
Figure 2: Diagnostic Mock-up

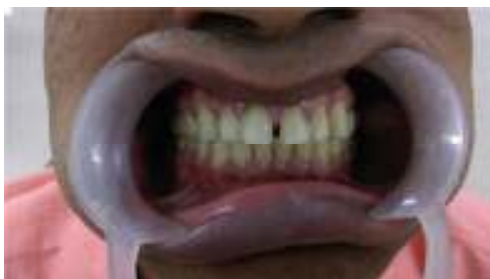
Figure 3: Tooth preparation for veneers

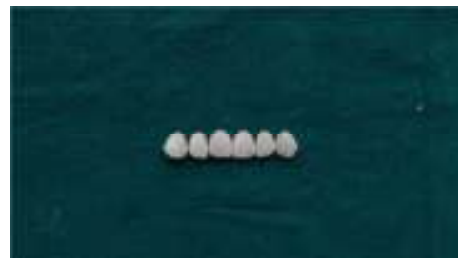
Figure 6(a): e.Max Veneers

The impression was send to the lab for fabrication of porcelain veneers (IPS – e. max) (Figure 6 a). Once the veneers were fabricated the patient was recalled for trial of the prosthesis. The esthetics and fit were verified in the mouth. After the verification was done the veneers were removed from the mouth and dried. The inner side of porcelain veneer was etched with 5% hydrofluoric acid (IPS Ceramic etching gel) for 20 seconds, washed under running water and dried. After this a bonding agent is applied and light cured. The prepared teeth were etched with 37% phosphoric acid etchant gel for 30 seconds. After that the bonding agent is applied (PRIME N BOND, DENTSPLY). Dual cure resin cement (RELYX U 200) was dispensed with a clicker dispenser, mixed and applied on the veneers. The veneers are seated in position and excess cement is removed with a probe and light cured. Excess cement is also removed after initial set (Figure 6 b) ⁸.

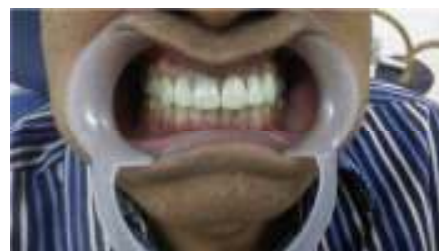
Figure 6 (b): Cemented Veneers

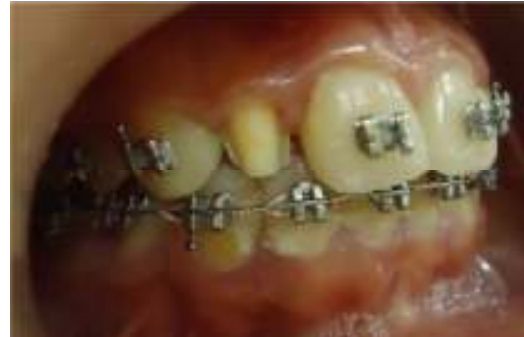
Figure 9 a: Tooth preparation on 12

A 20 year old female patient reported to the Department of Prosthodontics, Bharati Vidyapeeth dental college and hospital, Pune. Her chief complaint was spaces between the teeth and unesthetic smile (Figure 7, 8a and 8b). She had no relevant medical history. The treatment plan was discussed with the patient as above. It was decided to place porcelain veneers for the peg laterals. Procedure was carried out as above. (Figure 9a and 9b, 10, 11)

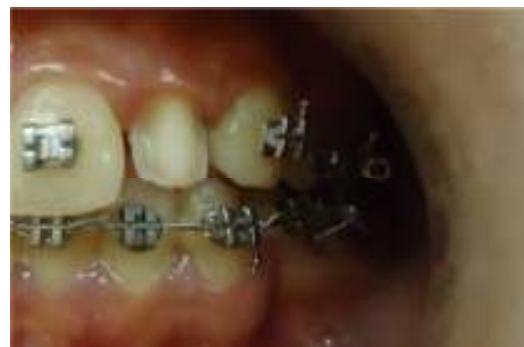
Figure 9 b: Tooth preparation on 22

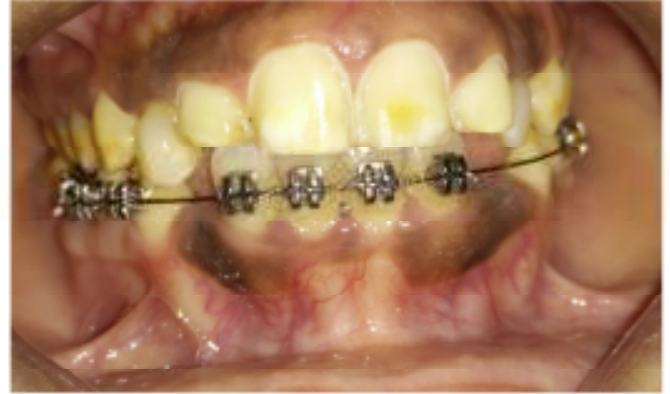
Figure 13: Tooth preparation for veneers form 12 to 22

A patient reported to the Department of Prosthodontics, Bharati Vidyapeeth Dental College and hospital, Pune with a chief complaint of stains in the teeth. Intraoral examination revealed intrinsic stains and were due to generalized enamel hypoplasia and fluorosis (Figure 12). Also the both the maxillary canine teeth were deciduous. The treatment plan was discussed with the patient as above and porcelain veneers were decided for the treatment option from 12 to 22. Tooth preparation for veneers was done as case I (Figure 13). After that veneer

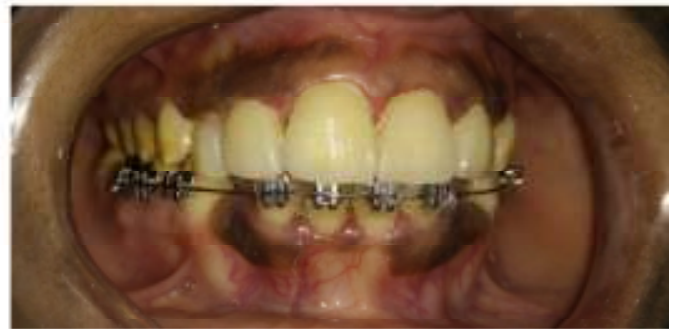
Figure 14: Post-operative view

cementation was done similar to above case (Figure 14).

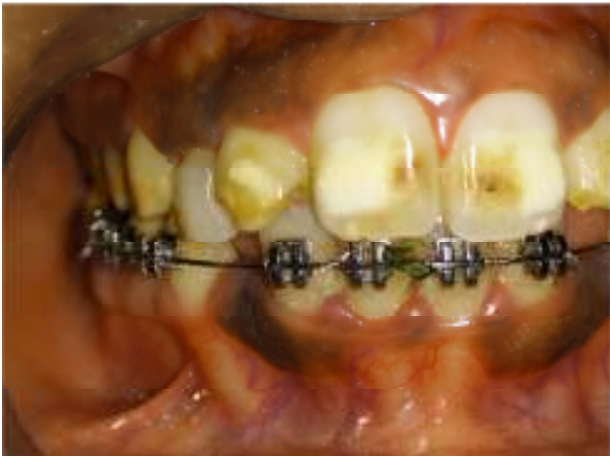
Figure 12: Pre operative view
